NO. 5 DAM
NDI ID NO. PA-00375
DER ID NO. 35-22

APRIL 1979

(6) National Dam Inspection Program
Number 5 DAM

PHASE I INSPECTION REPORT

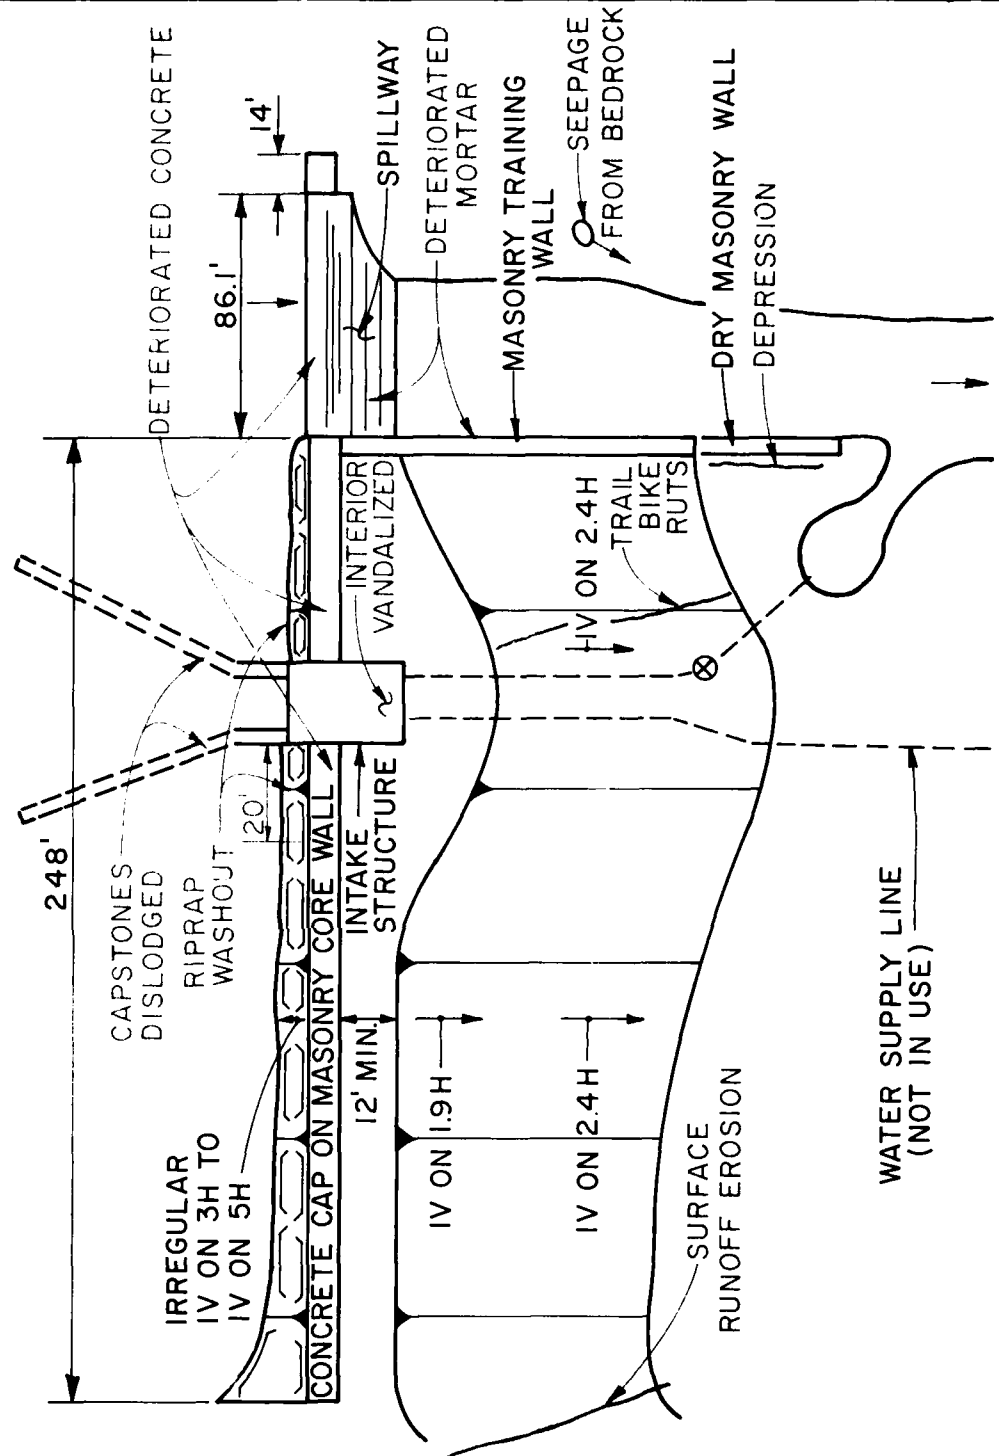
PHASE I INSPECTION REPORT
NATIONAL DAM INSPECTION PROGRAM
NO. 5 DAM
PENNSYLVANIA GAS AND WATER COMPANY
RESULTS OF VISUAL INSPECTION

a. General. The overall appearance of the dam is good. However, some deficiencies were observed as noted below. A sketch of the dam with the location of deficiencies is presented in Appendix B on Plate B-1. Survey information acquired for this report is summarized in Appendix B. On the day of the inspection, the pool was 0.1 foot above the spillway crest.
